A "New Deal" for a 75 Year Old WPA Bandshell

Slated for demolition a little less than a decade ago to make way for a parking lot, the Roxbury Bandshell in Johnstown, PA, shown in Figure 1, has been saved and rediscovered as a community asset. The bandshell, originally called the Municipal Music Pavilion, was one of twenty-seven bandshells built throughout the United States in the 1930s and 1940s under the Works Progress Administration (WPA).

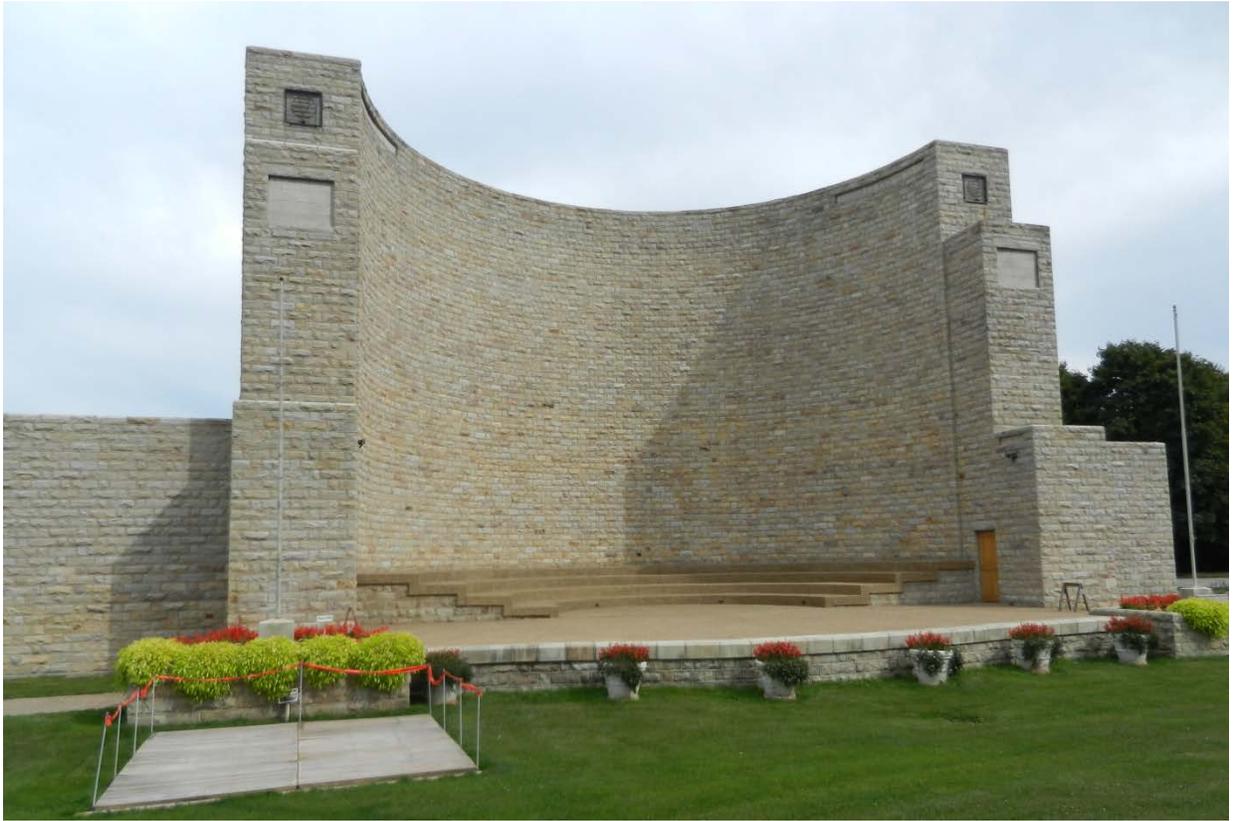
Figure 1. Restored Roxbury Bandshell, Johnstown PA (photo by Andy Rose)

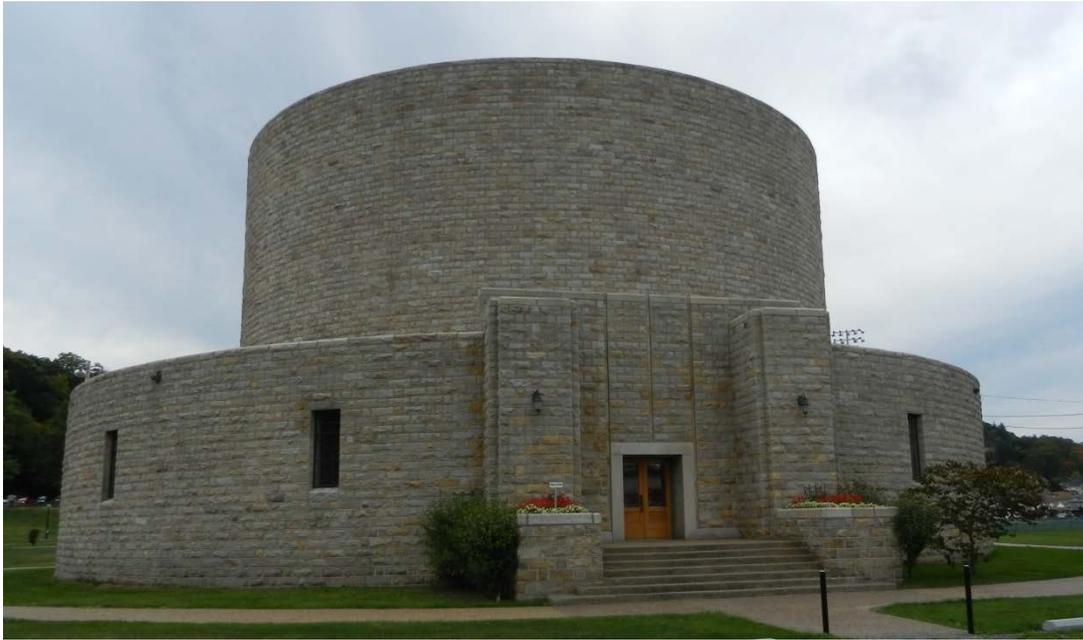
Figure 3. Street-side Entrance to Bandshell. (photo by Andy Rose)

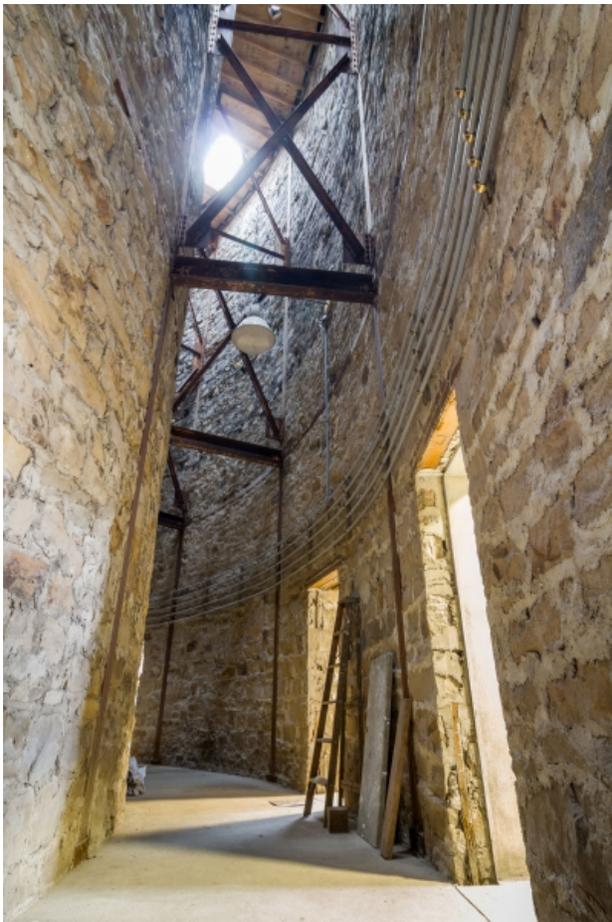
Figure 4. Interior Stonework and Steel Frame. (Photo By Phil Balko - philipbalko.com)

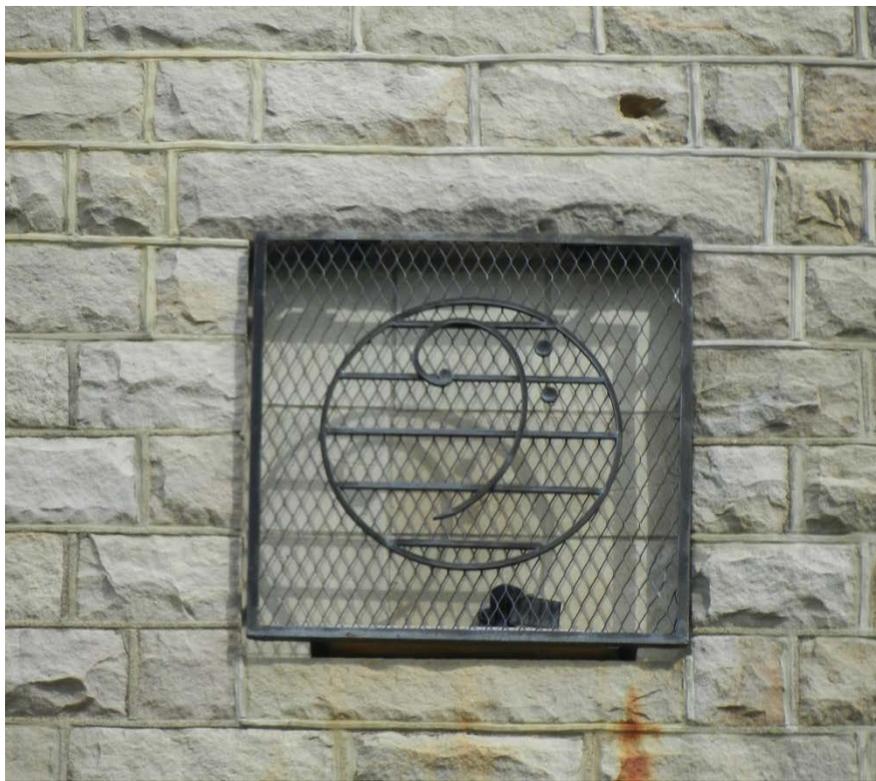
Figure 6. Ornamental detail on Bandshell. (photo by Andy Rose)
